# RESEARCH MEMORANDUM

AN INVESTIGATION OF THE EFFECTS OF RAPID SKIN  
HEATING ON BOX BEAMS LOADED IN BENDING

By Richard A. Pride

WASHINGTON  
March 23, 1955

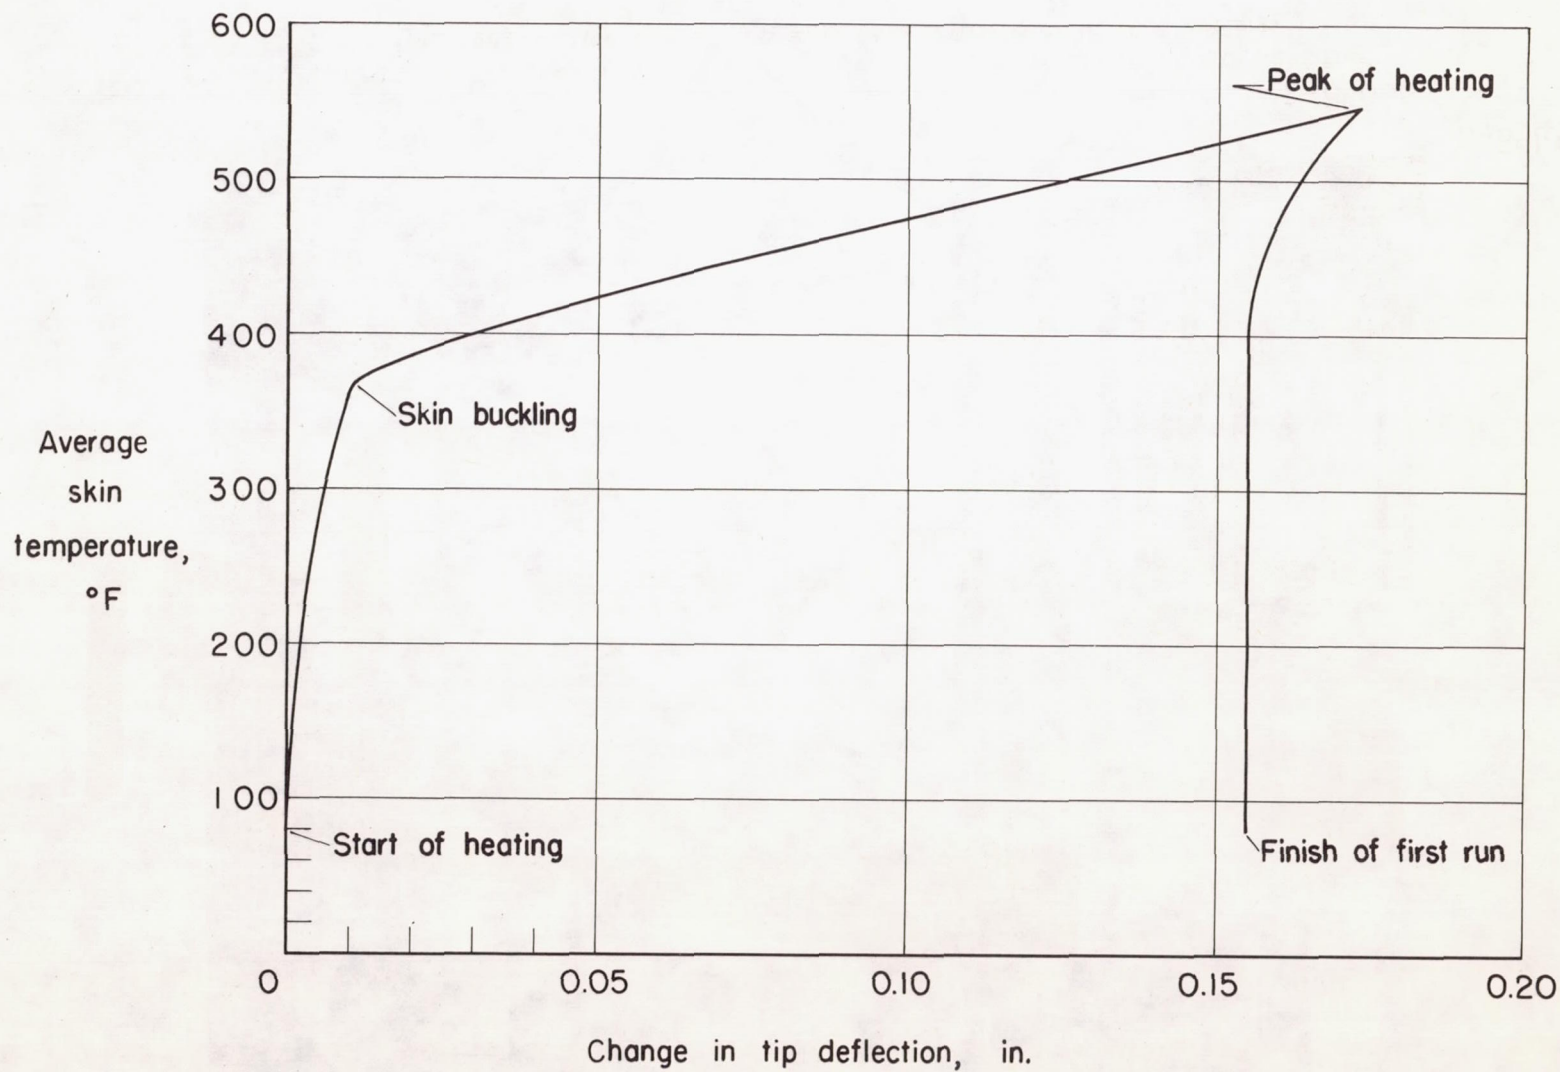
Thermal stresses did develop as the beam was heated and buckling of the compression skin occurred at an average skin temperature of 375° F. Buckling was detected by the abrupt change in rate of growth of tip deflection with heating as shown in figure 5. Continuation of the heating after buckling caused the beam deflections to grow rapidly but failure had not occurred when heating was terminated at an average skin temperature of 547° F. As the beam cooled off, the contraction of the buckled skin created sufficient compression to produce web buckling. Thus, after completion of the first heating cycle, deep buckles were present in both the skin and the webs and a permanent deflection remained.

After buckling of one skin surface of the beam, an unsymmetrical structure was created. Further heating of this unsymmetrical structure produced bending deflections. In this beam these deflections were larger than the changes in deflection produced by deterioration in material properties with temperature. (See fig. 5.)

Figure 5.- Change in tip deflection with change in skin temperature.  
 Channel-web beam 1;  $\sigma_b = 9.8$  ksi, first cycle; rapid skin heating  
 660 F/sec.

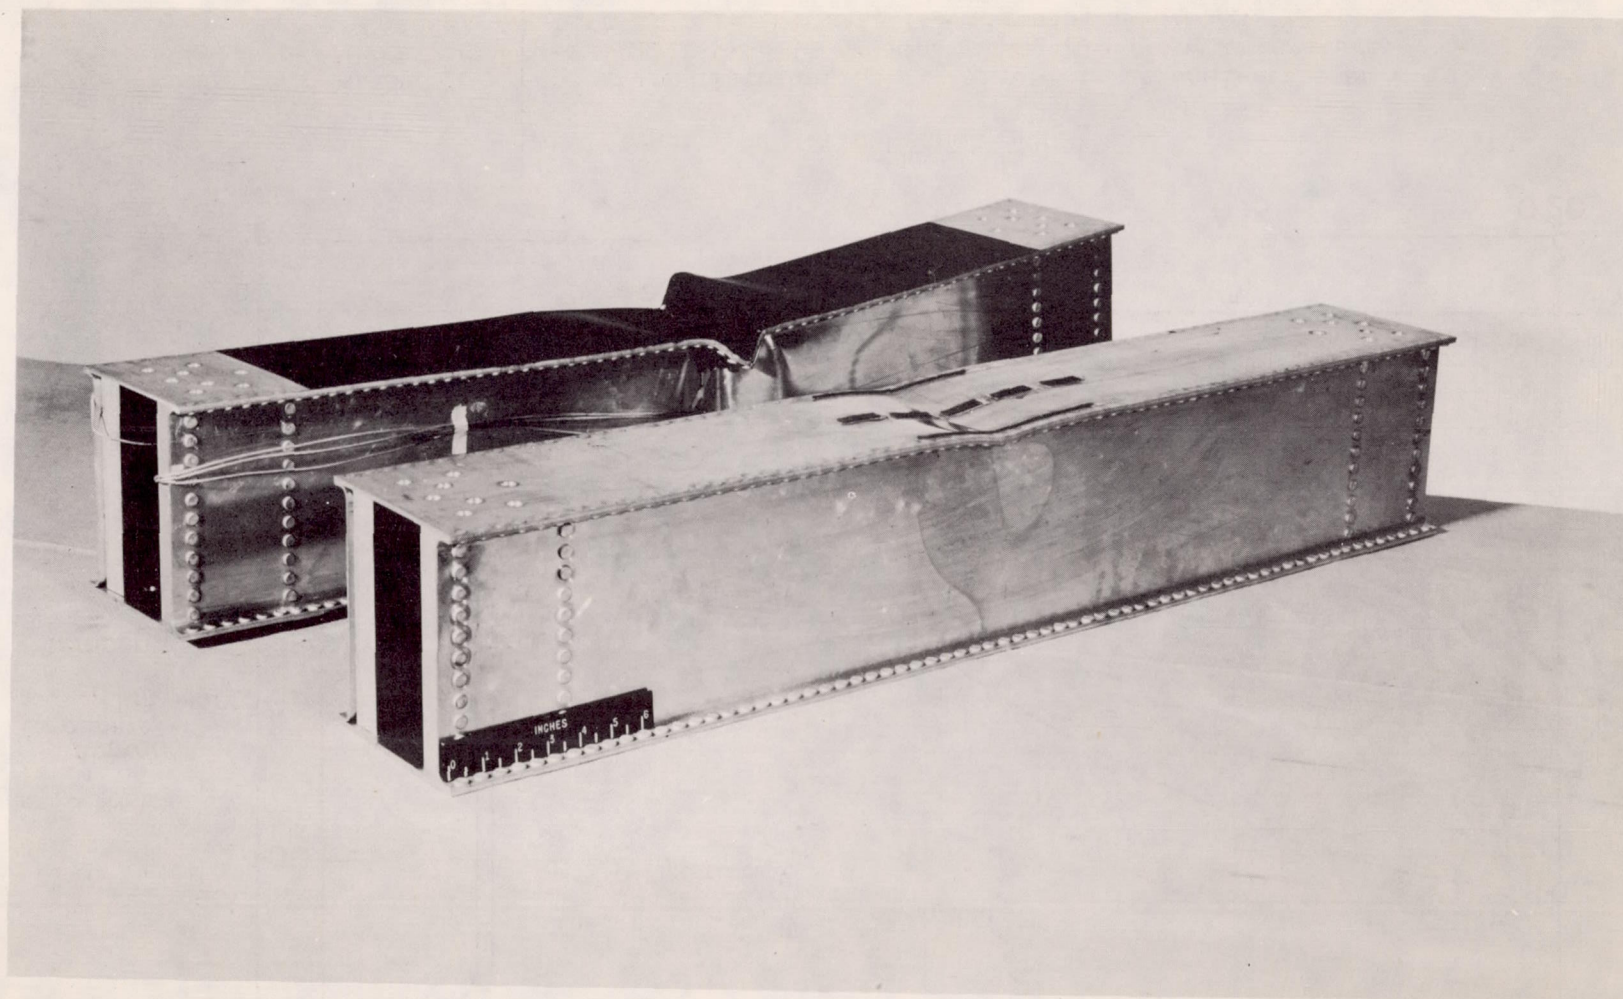
L-85459

After the twelfth cycle, the bending stress was increased incrementally with each heating cycle (table II) and the permanent deformations grew with each application of rapid heating until failure occurred with a bending stress in the skin of 22 ksi and an average skin temperature of 453° F. The failure mode was similar to the room-temperature failure in that the compression skin crushed the webs in the vicinity of the attachment flanges in a narrow wrinkle. Photographs of rapid-heating and room-temperature failures are shown in figure 6.

Figure 6.- Bending failure of channel-web beams after rapid heating (painted skin) and at room temperature (unpainted skin).

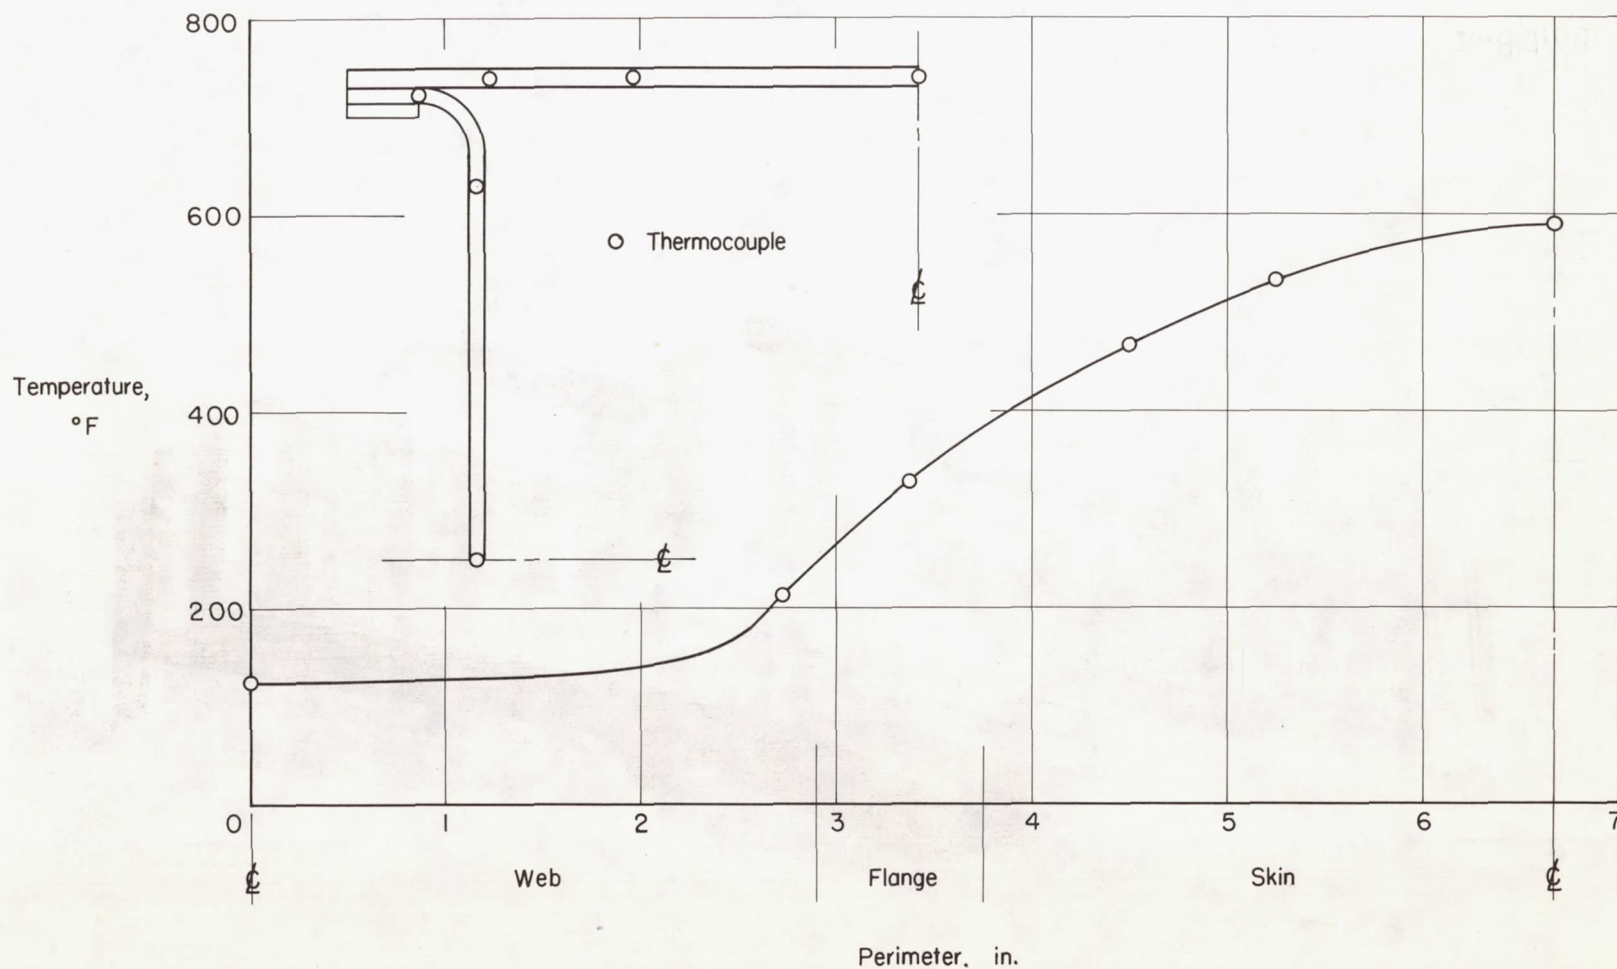
cycle reached its peak value with the average skin temperature at  $511^{\circ}$  F, thus, a reduction in strength from the thermal cycling was indicated. Again, a rapid growth of beam deflection was noted when heating was continued after buckling. Variation of temperature at failure in the center cross section is shown in figure 7.

Figure 7.- Temperature distribution at failure in channel-web beam 2.  
 $\sigma_b = 22$  ksi; skin heating rate,  $72^\circ$  F/sec.

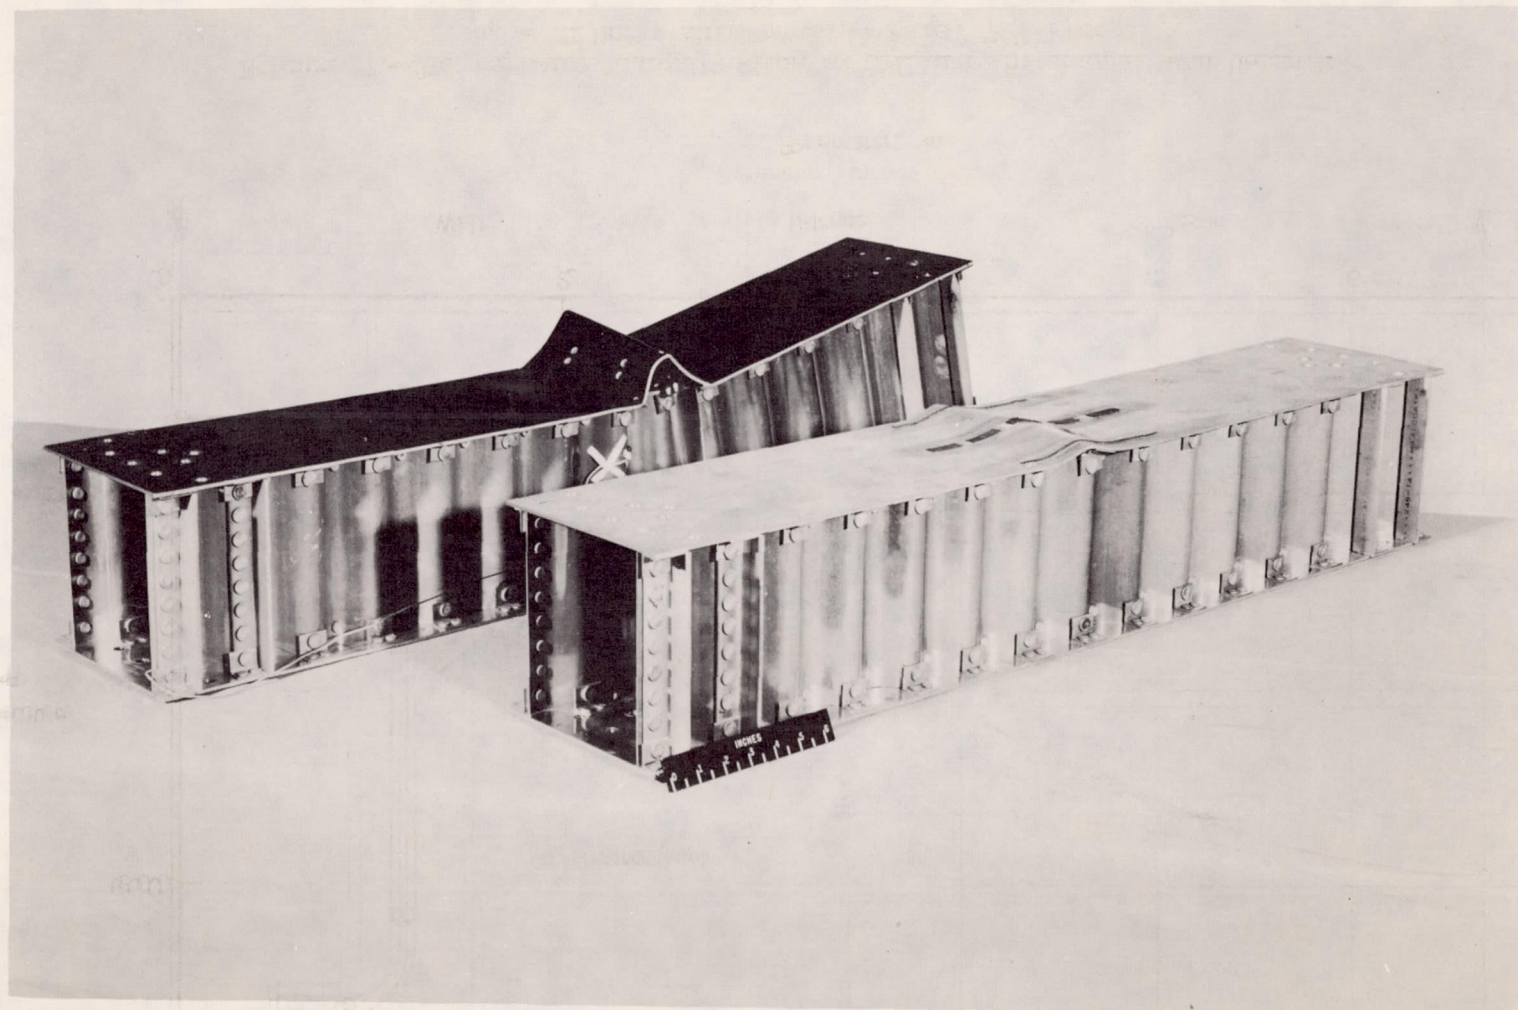
L-85460

Failure occurred during the first cycle of rapid skin heating at an average skin temperature of  $520^{\circ}$  F which is comparable to the  $511^{\circ}$  F at failure in the second channel-web beam. No evidence of buckling prior to failure was observed either visibly or by abrupt changes in growth of the tip deflection. Tip deflections increased with temperatures as a result of a decrease in material modulus. At failure the compression skin developed a wrinkle which pulled away from the webs and broke attachment angles and rivet heads. This type of failure is similar to the room-temperature failure as is shown in figure 8.

Corrugated-web beam 2.- Corrugated-web beam 2 was tested at the same bending stress as channel-web beam 2 to determine the maximum temperature at which it can carry the same stress (22 ksi). Failure occurred in the same manner as that for corrugated-web beam 1 but with a static skin stress of 22 ksi and at an average skin temperature of  $546^{\circ}$  F. Variation of temperature in the center cross section at the time of failure is shown in figure 9. At this stress level the corrugated-web beam failed at only slightly greater temperatures than the channel-web beam even though no buckling occurred, possibly because material properties are changing rapidly.

Figure 8.- Bending failure of corrugated-web beams after rapid heating (painted skin) and at room temperature (unpainted skin).

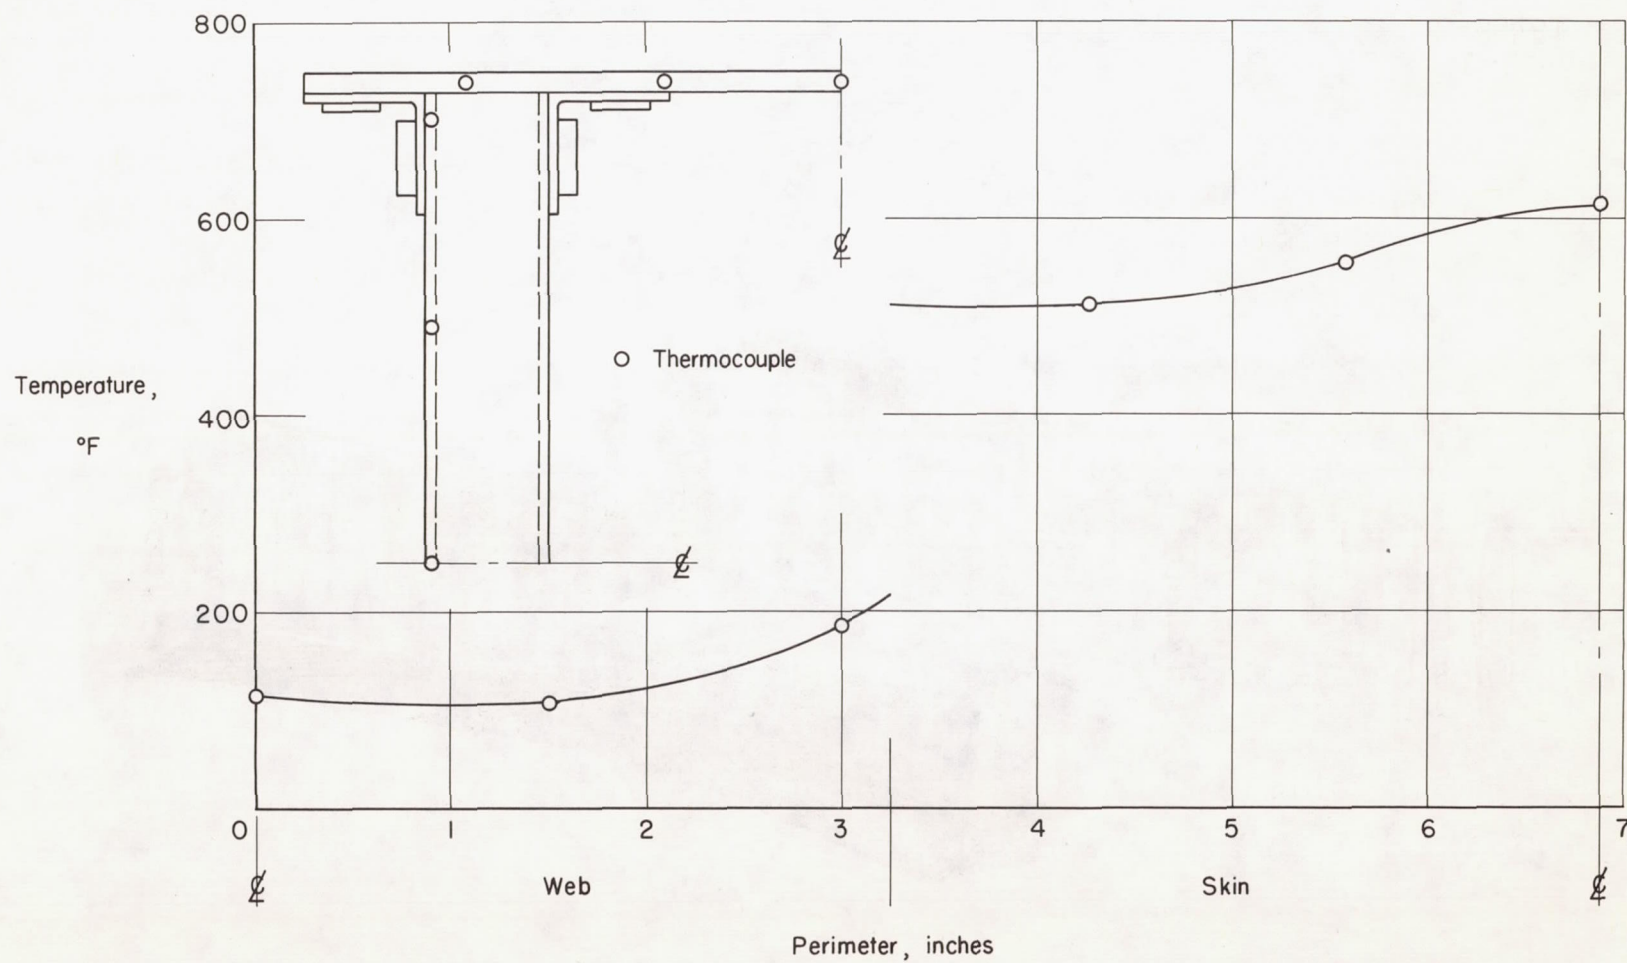
Figure 9.- Temperature distribution at failure in corrugated-web beam 2.  
 $\sigma_b = 22$  ksi; skin heating rate,  $57^\circ$  F/sec.

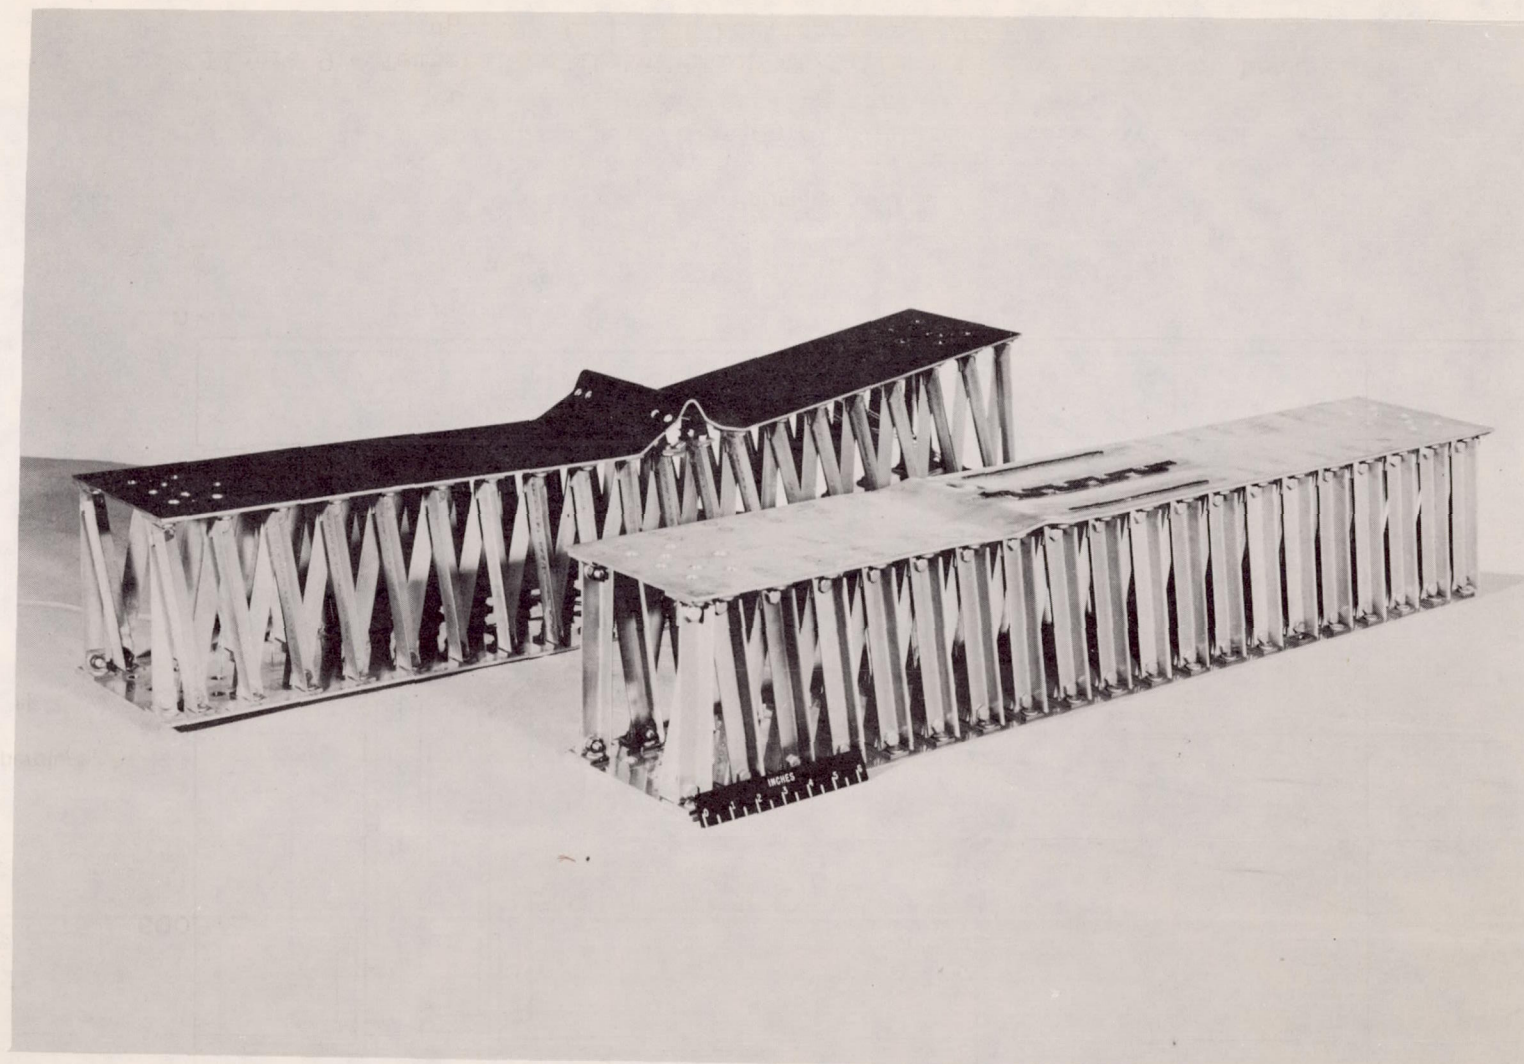
L-85461

When the average skin temperature reached  $457^{\circ}$  F, column-type failure of the compression skin occurred between truss panel points in the same manner as that for the room-temperature failure. (See fig. 10.) This failing temperature was lower than those for the channel-web beam 2 and corrugated-web beam 2, both of which were carrying the same skin stress. Variation of temperature in the center cross section at the time of failure is shown in figure 11.

Figure 10.- Bending failure of truss-web beams after rapid heating (painted skin) and at room temperature (unpainted skin).

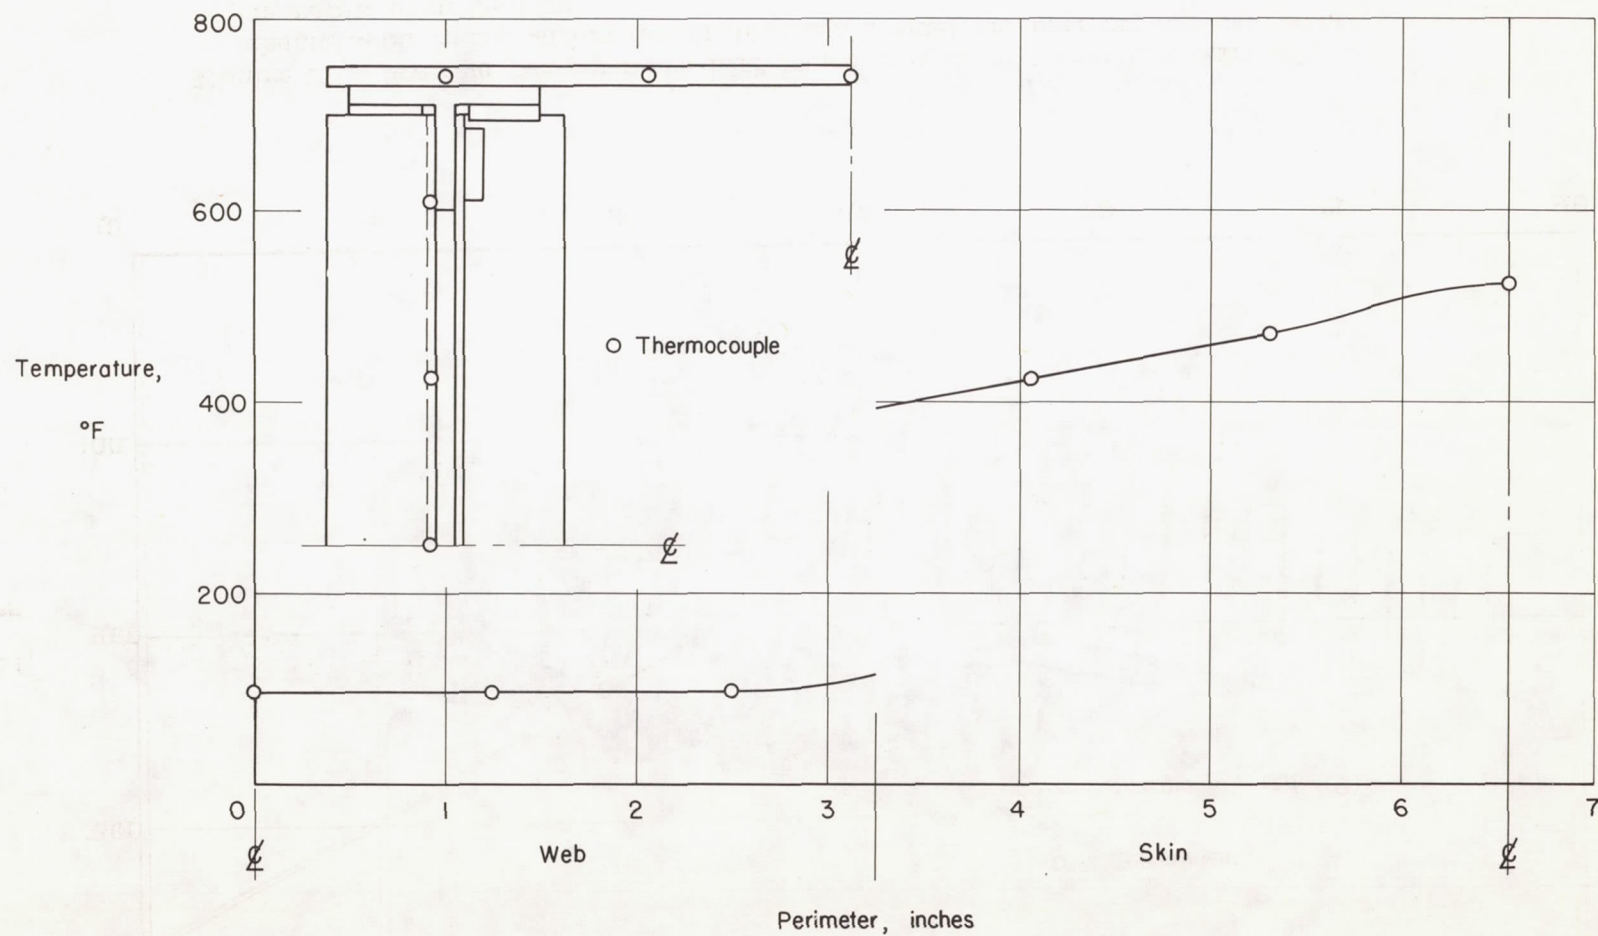
Figure 11.- Temperature distribution at failure in truss-web beam 1.  
 $\sigma_b = 22$  ksi; skin heating rate,  $66^\circ$  F/sec.

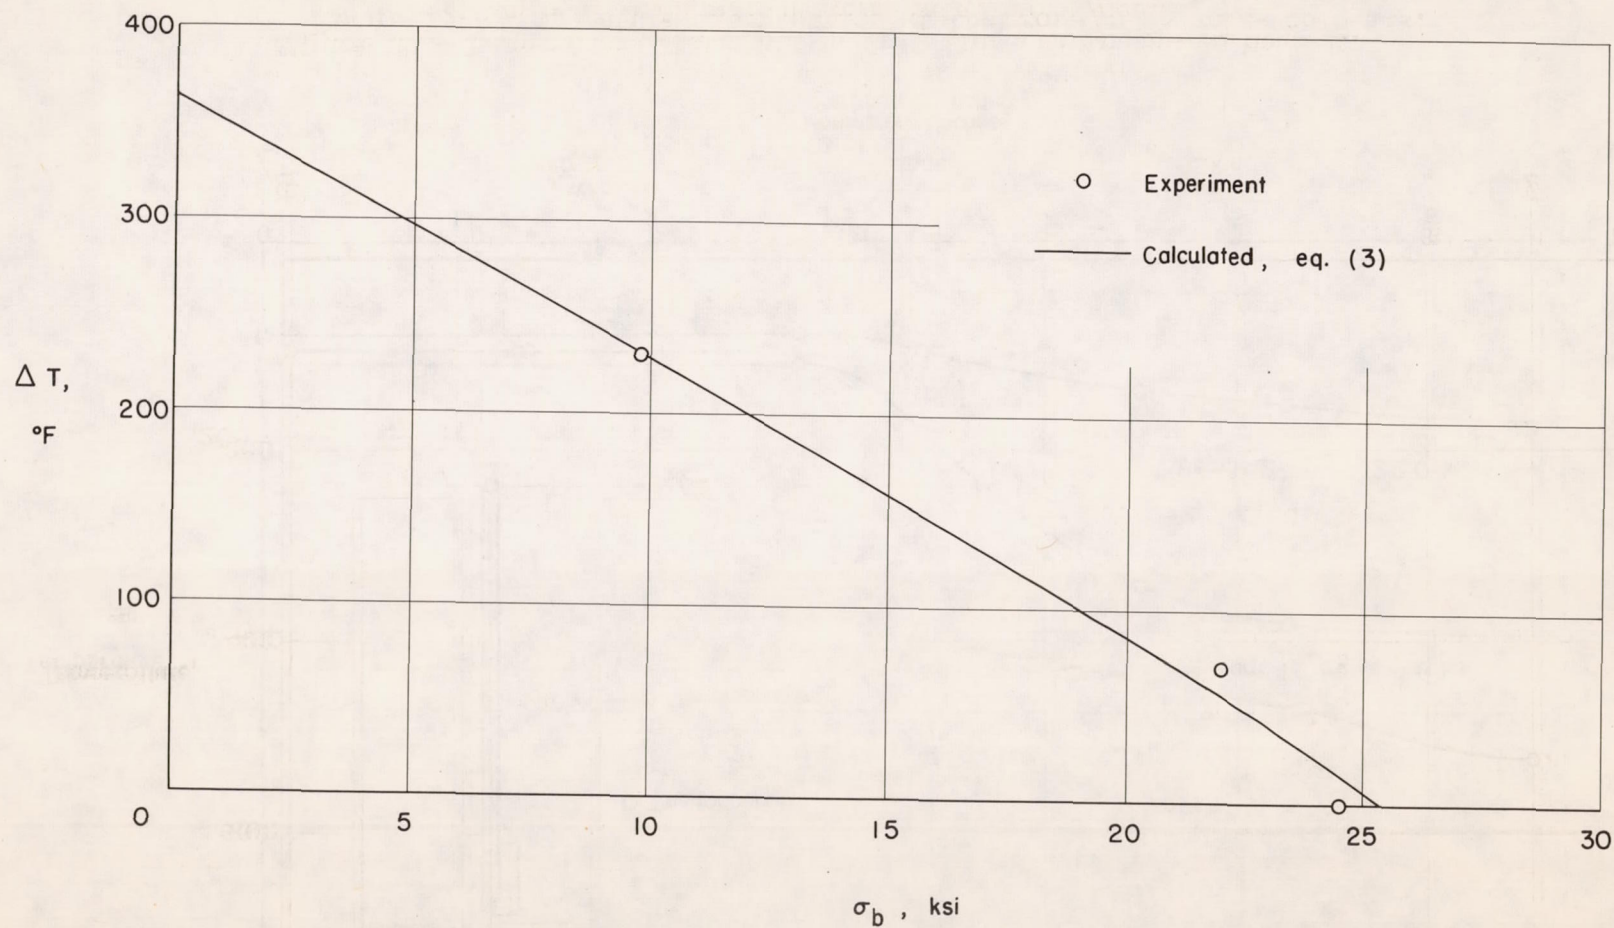
Comparison of average-temperature differences observed experimentally when buckling occurred in the two channel-web beams with those calculated from equation (3) is shown in figure 12. The curve was calculated on the assumption that web material properties were the same as those at room

The correlation between the calculated curve and experimental values of  $\Delta T$  at buckling shown in figure 12 indicates that the elementary buckling analysis presented here is adequate for the heating rates used.

Figure 12.- Average temperature difference required to buckle skin of channel-web beams which are statically loaded in bending and subjected to rapid skin heating.

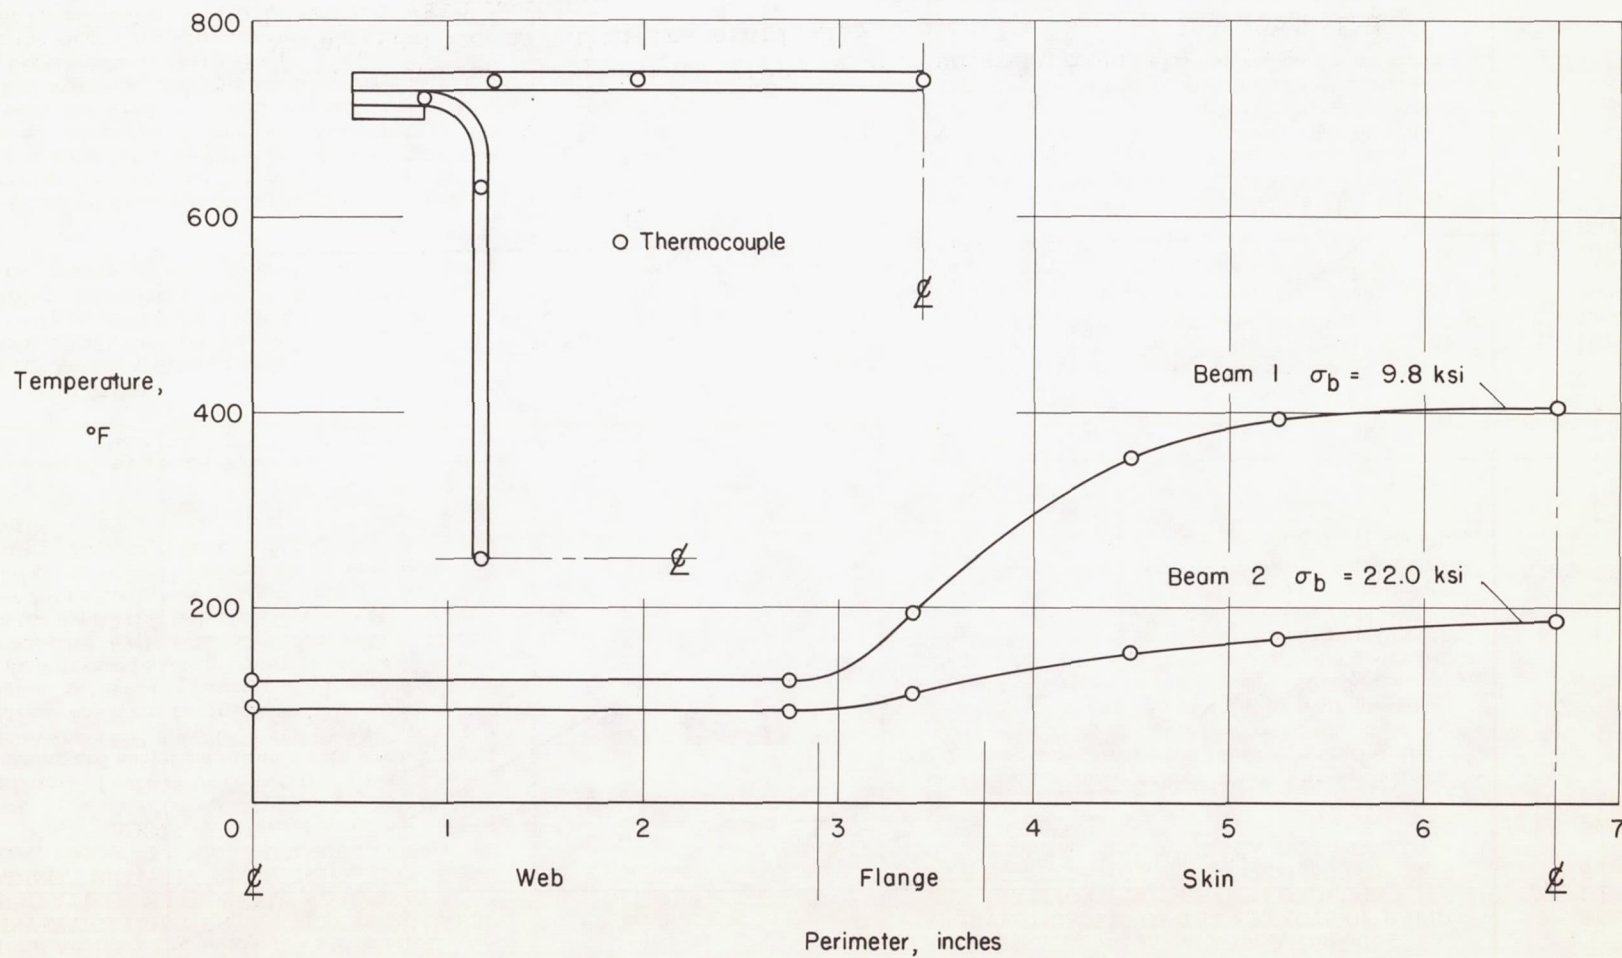
The experimental temperature difference between skin and webs (fig. 12) was taken from average temperatures for each element. Figure 13 shows the temperature distribution at the center cross section in the two channel-web beams when buckling occurred. Average temperature of skin or of webs was computed from a smooth-curve distribution through the points at which temperature was measured.

Figure 13.- Temperature distribution at buckling in channel-web beams.
